## Assessment of quality and sustainable usage of water resources in varthur lake of bengaluru, karnataka

Mithun C<sup>1</sup>, Dr H U Raghavendra<sup>2</sup>

1. Department of Civil Engineering RIT, Bengaluru 560096.

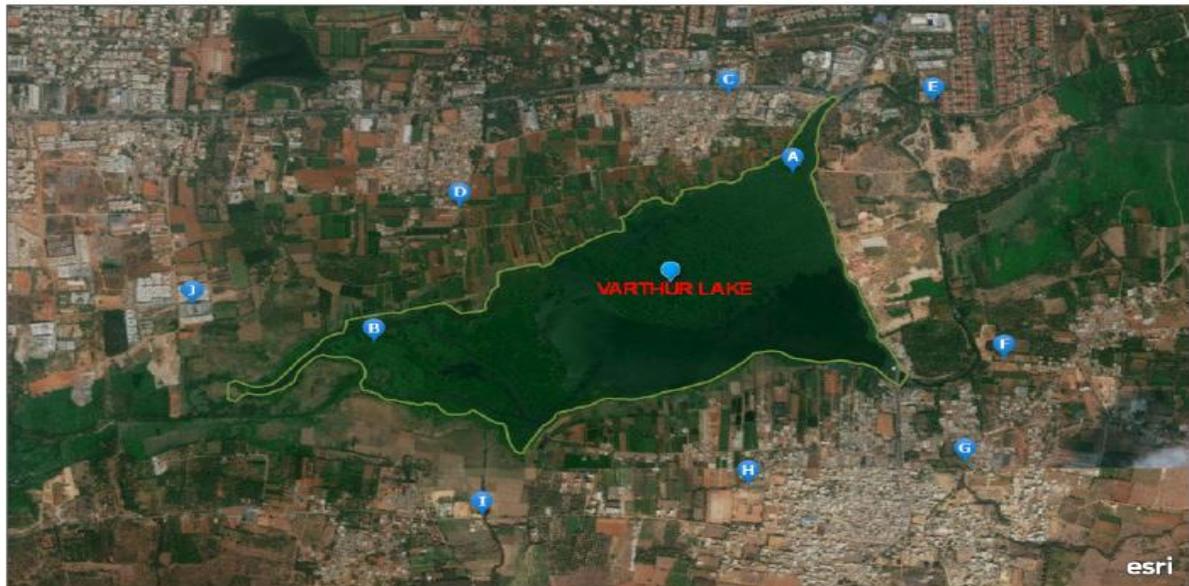
Figure 2: Samples locations of the study area in Post monsoon (Dec 2017)

Field investigation & samples collection are chosen to have good spread over the entire study area (Fig.2 & Fig.3). The latitude and the longitude of each sample location is been listed in the Table 1.

<b>Table 1: Location of the sample collected</b>				
<b>Sample No</b>	<b>Latitude of Location</b>	<b>Longitude of Location</b>	<b>Distance from the lake banks</b>	<b>Sample collection</b>
A	12.9533	77.7434	0	The sample was collected during Post Monsoon (Dec 2017) & Pre monsoon (Apr 2018)
B	12.9457	77.7276	0	
C	12.9567	77.7408	310-320	
D	12.9519	77.7317	500-510	
E	12.9568	77.7486	470-480	
F	12.9463	77.7508	450-465	
G	12.9415	77.7492	480-500	
H	12.9405	77.7414	495-510	
I	12.9390	77.7326	450-475	
J	12.9478	77.7228	480-500

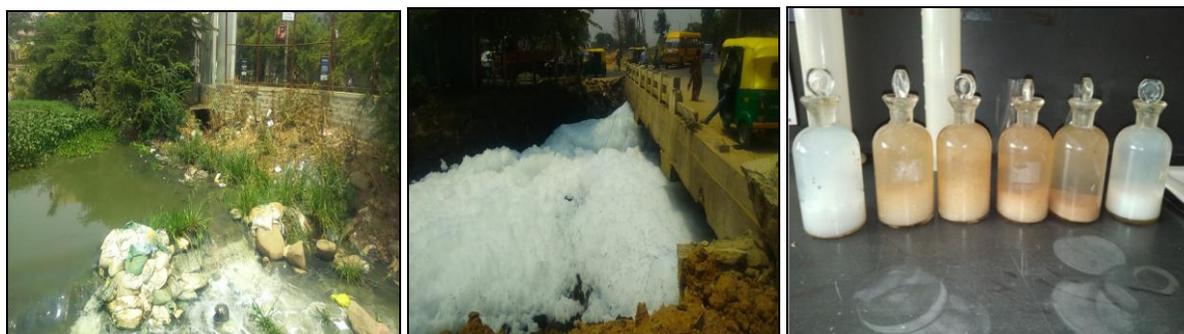
**Fig.4 photos of lake and water samples**

Some visual evidences were noted and recorded. Color of the water from the lake was found to be sandy, foul smell & foam (Fig. 4)

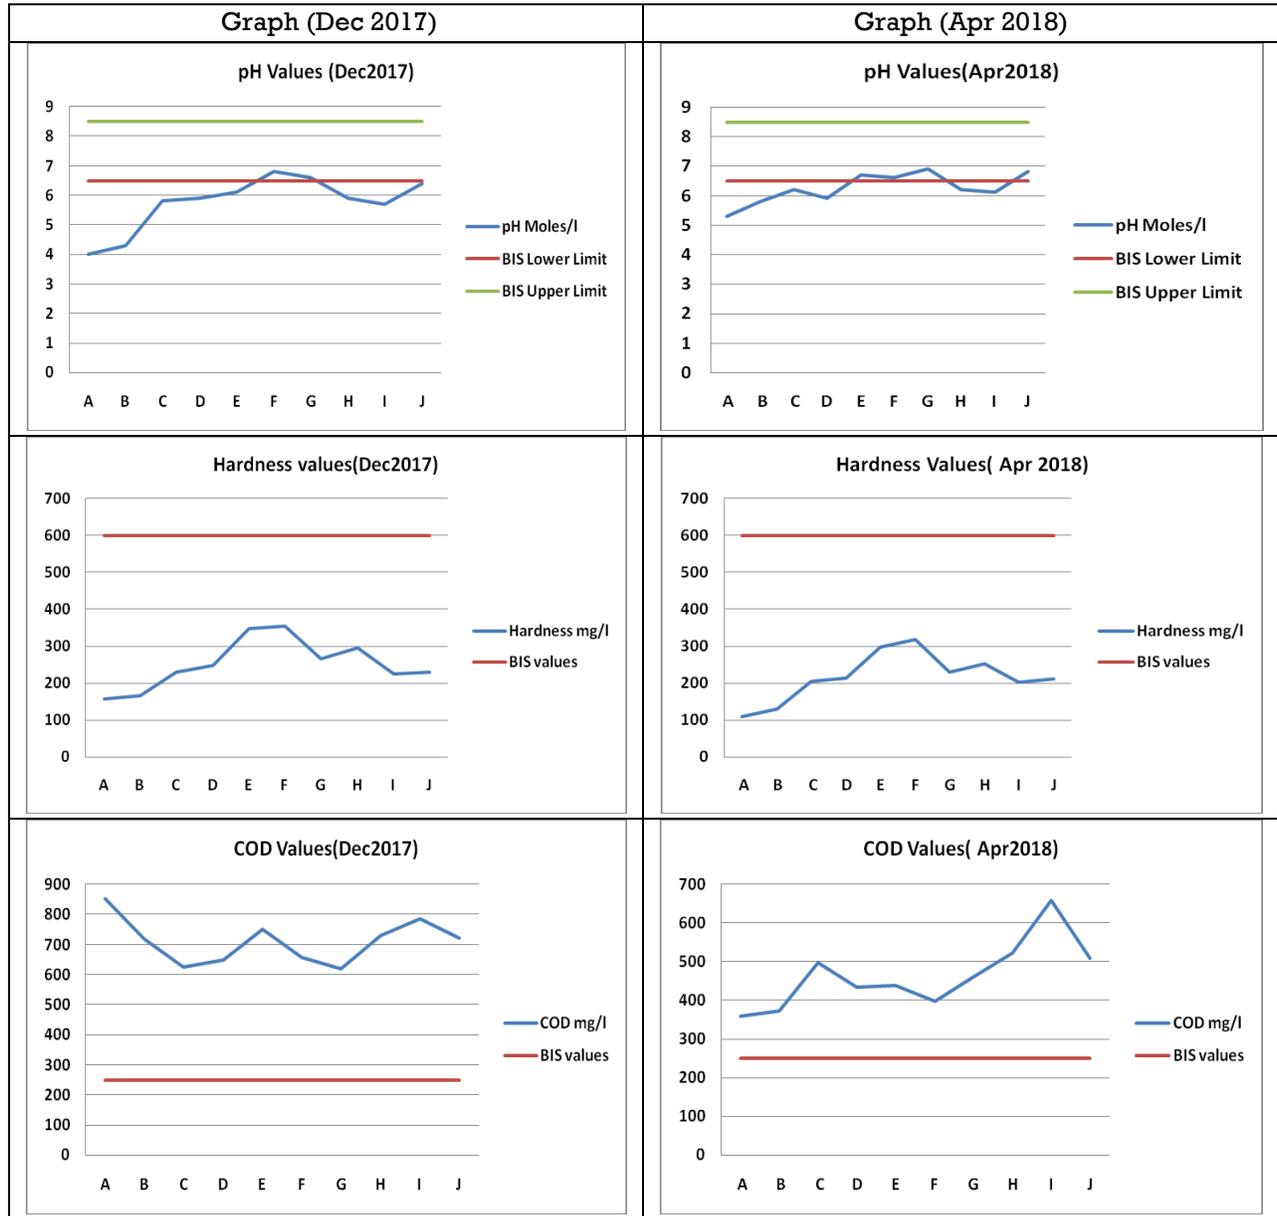
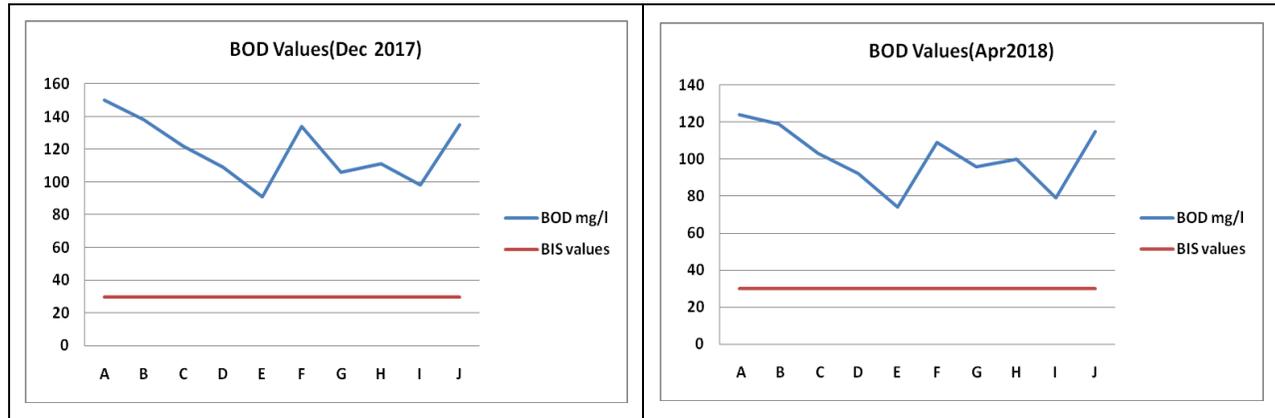
**Fig 5: Comparative Graph for the chemical parameters tested during the post and pre monsoon season.**

Temperature of water is basically important because it effects biochemical reactions in aquatic organisms. A rise in temperature of water leads to the speeding up of chemical reactions in water, reduces the solubility of gases and amplifies the tastes and odor (Ramesh N & Krishnaiah S, 2014). The chemical parameter shows there is high level of contaminants in the lake as well the ground water is also polluted when compared with the drinking standard parameters (Fig 5).

As the graph represents the effluent level in the samples for Post monsoon and Pre monsoon is relatively high when compared with the standard values of BIS. Untreated sewage, solid waste, municipal, and industrial effluents are the factors which are contributing in the lake deterioration. Contaminants in the lake have also led to the decrease in quality of the ground water when it is recharged in and around the lake area.

As the above results show the existing water in the lake was not fit for drinking because the criteria which is given by BIS was not satisfied.

The BOD level in the lake is found to be higher than the recommended values shows the presence of nitrates and phosphates which automatically increases the BOD levels. These also lead to quick growth of algae and weeds in the lake. As the weeds grow at faster rate, it decreases the D.O levels in the lake because the oxygen which is available in the water is consumed by the bacteria. Since less D.O is present in the lake water, it affects the aquatic life (Pattusamy V et al., 2013). The other reason is due to the presence of organic waste.

The COD difference in the results of the samples are very high after rains which indicates that the values from industrial waste has the presence of  $H_2O_2$  which can play a role in alteration of COD and parameters keeps on fluctuating.

Hardness considerations vary from 60-180 where 60 refer to soft; 60-120 refers to moderately hard & 120-180 refers to hard. The readings from lake study is very hard referring  $>180$  indicates the large extent of calcium and magnesium intake which effects the human health such as Cardiovascular disease, cancer, diabetes, effects the nervous system etc and also aquatic life.
